**Report on 2010 Mayo Creek Salt Marsh Pre-Restoration Monitoring**  
Prepared for the Town of Wellfleet Conservation Department

Submitted by Tara Nye, Katherine Beauchamp and Jo Ann Muramoto  
Association to Preserve Cape Cod  
January 20, 2011

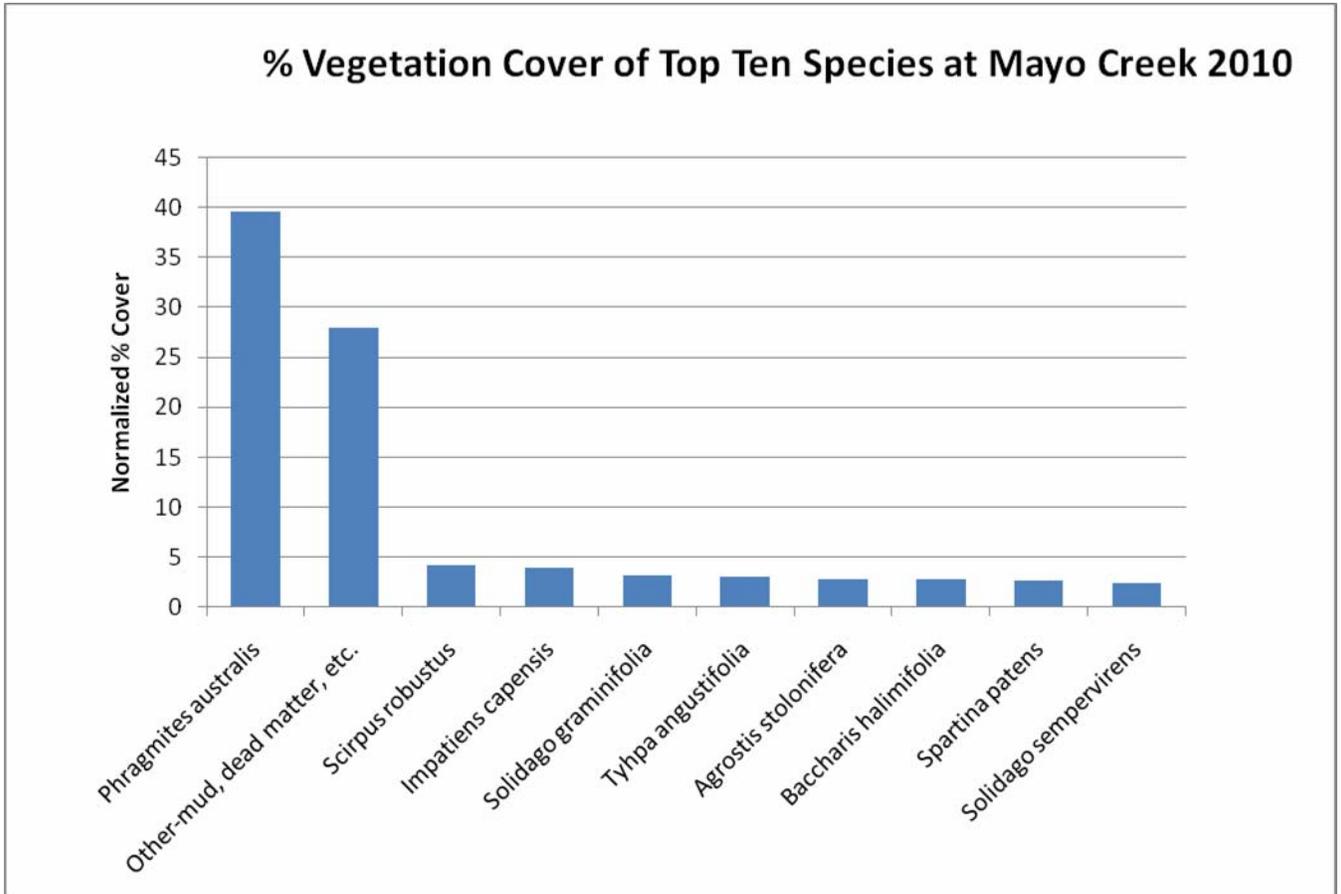
The Mayo Creek marsh upstream of the tidal restriction contains a vegetation community dominated by the invasive Common Reed, or *Phragmites australis* (Figure 1). *Phragmites* exhibited percent vegetation cover of nearly 55% (Table 3), which is more indicative of a brackish or fresh marsh. A healthy salt marsh typically has a high abundance of halophytes such as *Spartina alterniflora*, *Spartina patens*, and *Distichlis spicata*. Another observation worth noting is the high abundance of bare ground and dead plant material (Figure 1).

Figure 1. Percent vegetation cover of Mayo Creek plants.

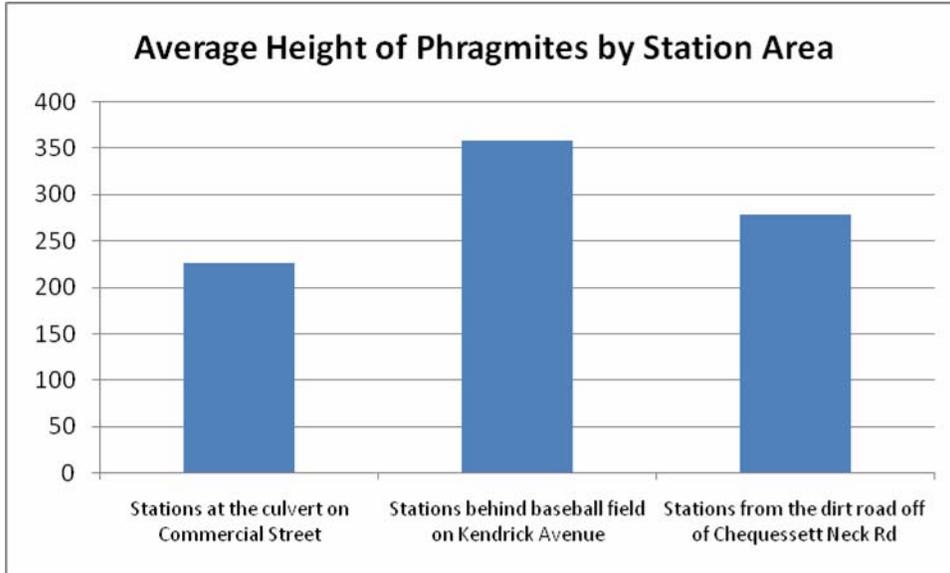
Of particular interest was the abundance and height of the invasive and opportunistic *Phragmites australis* (Figure 2 and Table 4). *Phragmites* stem heights were measured and then averaged by location. For example, all of the *Phragmites* stems measured near the culvert (transects S1, S2 and S3) were averaged together to represent *Phragmites* abundance and height in the vegetation community closest to the tidal restriction,

similarly, the heights of *Phragmites* measured along the transects behind the ball field (transects S4, S5 and S6) were averaged together, and the transects off the dirt road running into Chequessett Neck Road (S7, S8, S9 and S10) were averaged together. As seen in Figure 2, there is a trend of increased *Phragmites* height at stations located farther upstream, away from the restriction.

Figure 2. Average height of *Phragmites australis* in Mayo Creek.

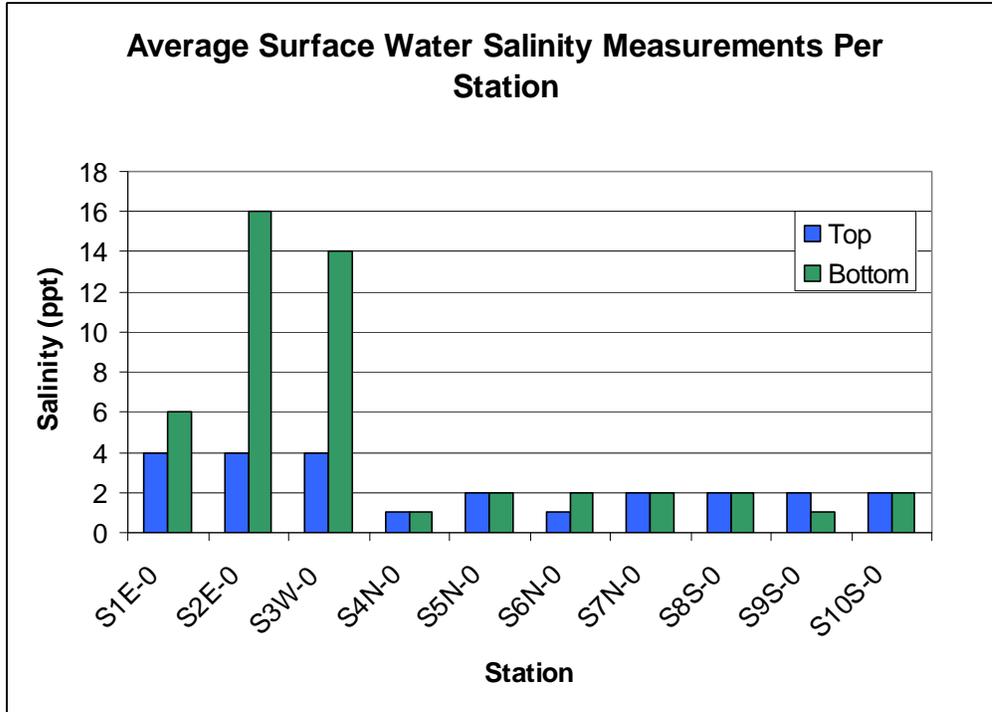
Surface water salinity was measured at most of the zero stations, which were located on the creek banks. As anticipated, there was a definite stratification in the section of the creek near the culvert (transects S1E, S2E, and S3W) with fresher water on the top and higher saline water on the bottom. The data indicate a definite decrease in surface water salinity concentrations upstream of transect S3W (Figure 3). At the time of monitoring, the creek was fairly deep with a very muddy bottom.

Figure 3. Average surface water salinity measurements at stations in Mayo Creek salt marsh, 2010.

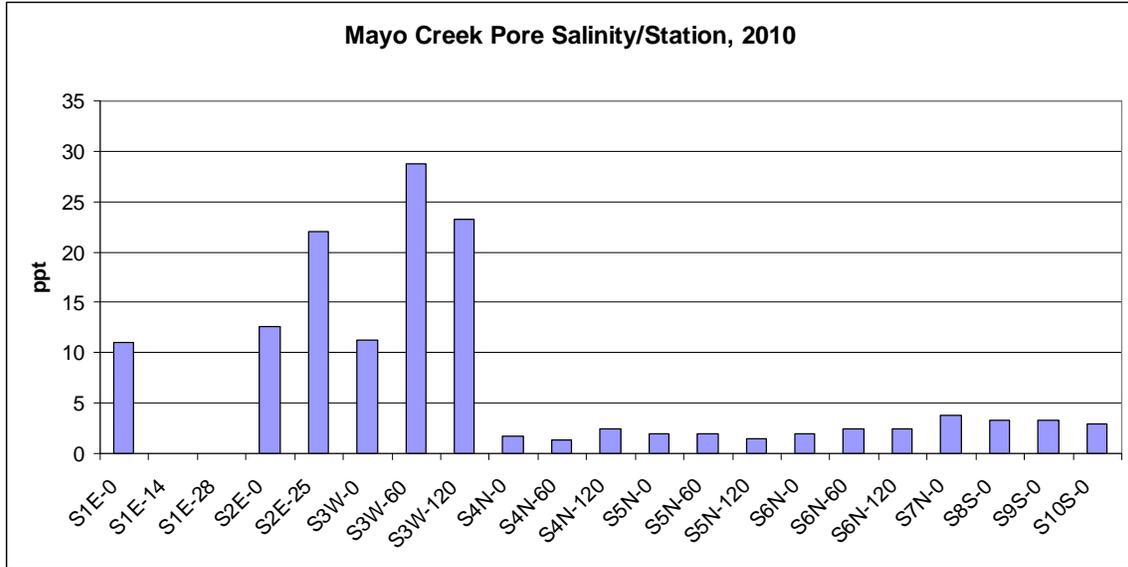
Pore water salinity measurements were taken from 10 cm below the marsh surface. Again, a definite trend is seen where salinity concentrations fall sharply upstream of transect S3W (Fig 4). The stations S1E-14 and S1E-28 were dry the entire season; it was not possible to obtain even a single sample from the 10 cm depth at either of these stations.

Figure 4. Average pore water salinity measurements at stations in Mayo Creek salt marsh, 2010.

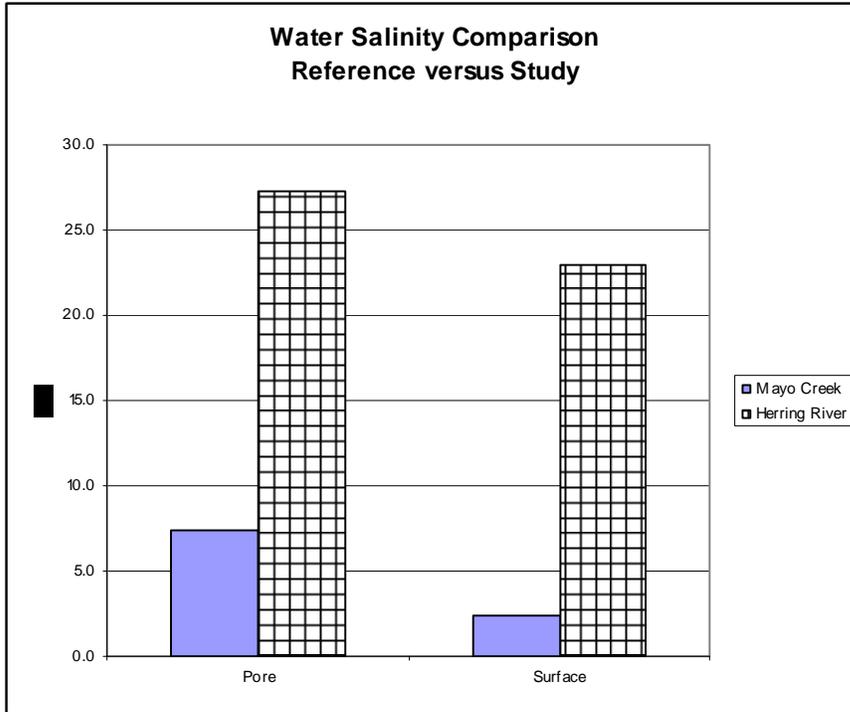
Pore and surface water salinity measurements taken at Herring River in Wellfleet during the summer of 2009 were used as reference data. In Figure 5 the difference in salinity values between the unrestricted side of Herring River and the restricted side of Mayo Creek can readily be seen.

Figure 5. Herring River reference salinity data and Mayo Creek study salinity data.

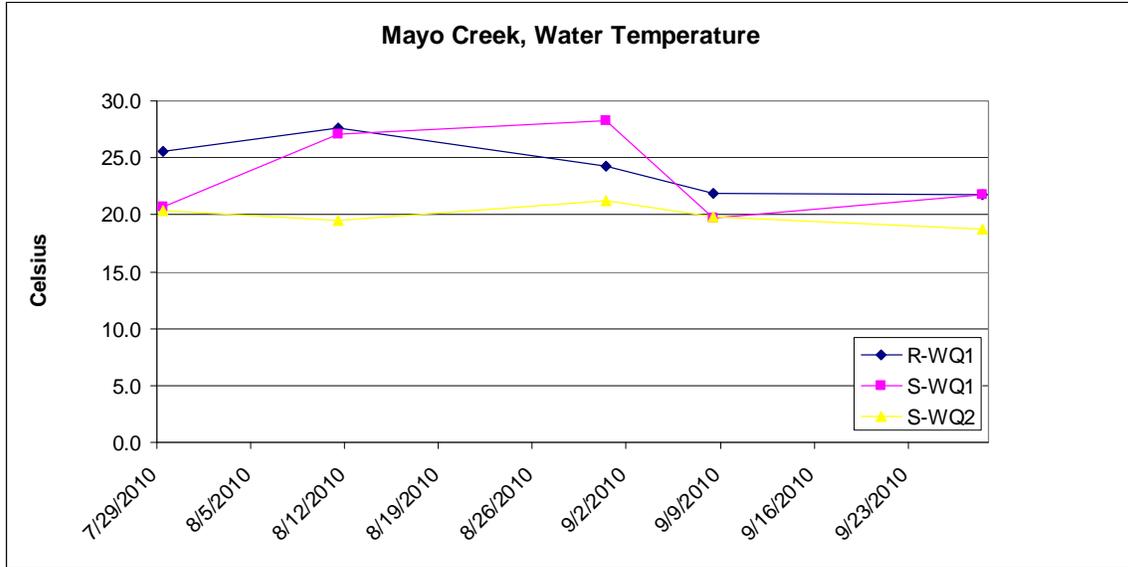
The water surface temperature measurements show no particular pattern or trend, with the exception of a slight decrease in temperature at all sites after September 2, 2010 (Figure 6). In fact, it seems surprising that S-WQ2 station is consistently the coldest given its shallowness and stagnation.

Figure 6. Surface water temperature at Mayo Creek YSI stations, 2010.

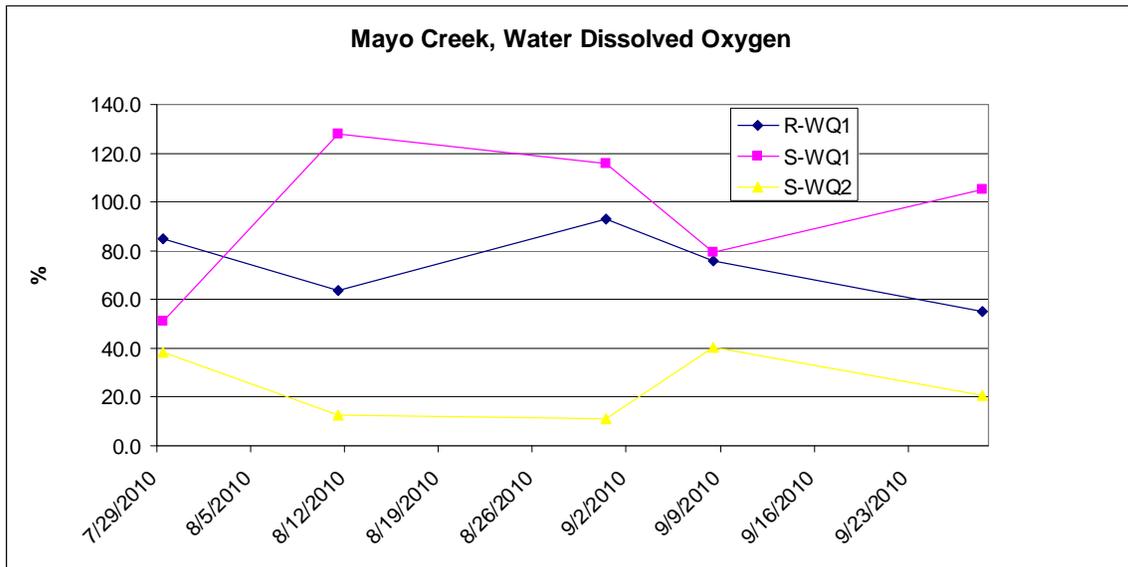
It is not surprising however, that the dissolved oxygen data at station S-WQ2 reflects dangerously low levels of dissolved oxygen in the water (Figure 7). The water level here is shallow with far more mud and muck than water. One unfortunate step off of the “board” walk by an intern demonstrated that although the water appears to be only a few centimeters deep, the muck is in fact approximately at least one meter in depth. The actual creek bottom was not determined at this station.

Figure 7. Surface water dissolved oxygen concentrations at Mayo Creek YSI stations, 2010.

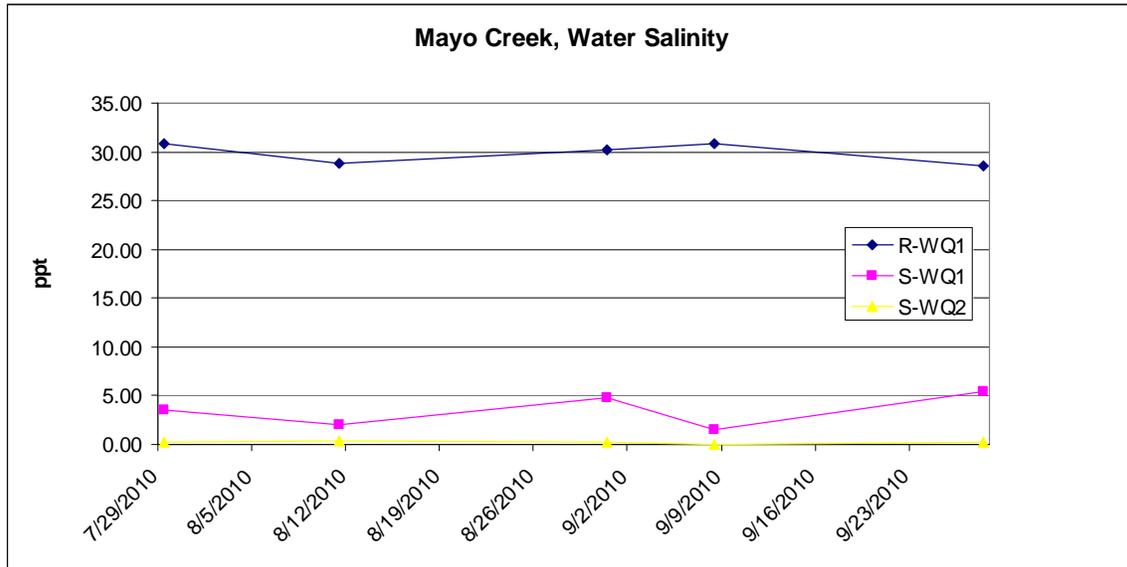
The surface water salinity on the study (restricted) side of the marsh is lower than the salinity on the reference side of the marsh (Figure 8). The difference between the salinity at S-WQ1 (study side of culvert) and R-WQ1 (reference side of culvert) is as great as 29.2 ppt. The difference between the two study stations, S-WQ1 and S-WQ2, is minimal, ranging between two and five ppt.

Figure 8. Surface water salinities at Mayo Creek YSI monitoring stations, 2010.

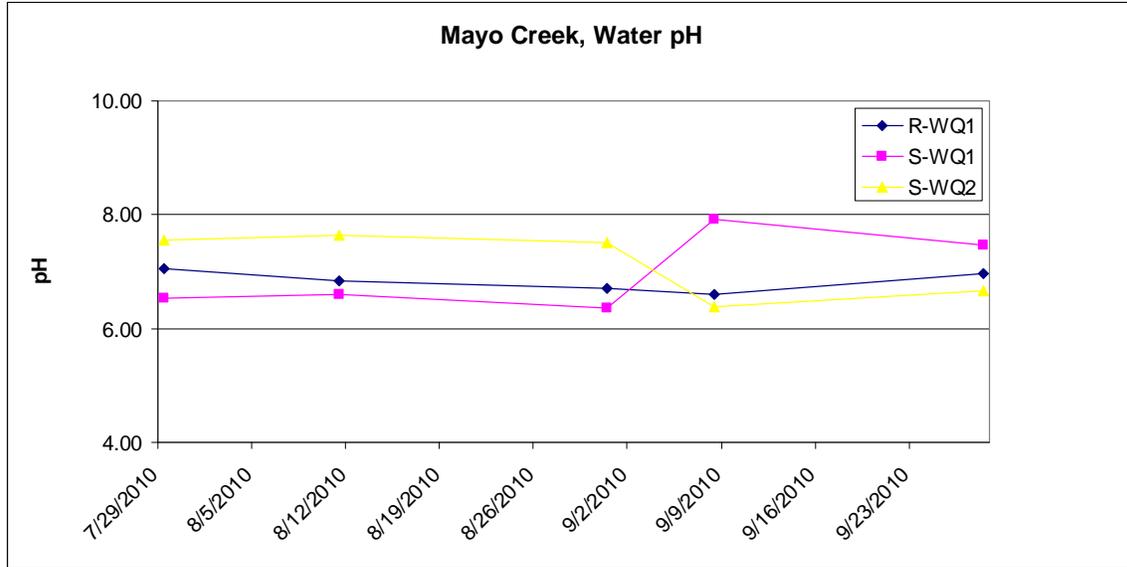
Measurements of pH at monitoring stations indicate that pH falls within a range typical of wetlands exposed to fresh and brackish water as well as seawater. Higher pH levels can be assumed to reflect seawater, which has a pH closer to 8. The pH of fresh water is typically around 7 but can be lower due to acid precipitation; ponds and lakes on Cape Cod often have a pH of 6 or so. Lower pH can also occur in salt marshes undergoing oxidation through diking or other excavation. The cause of acidification in such cases is the oxidation of iron sulfides (present in salt marsh sediments) to sulfuric acid (Portnoy, 1999). The water pH measurements at YSI stations S1 and S2 seem to be mirroring each other through out the season, where as the measurements taken at the unrestricted station, R1, are very level and consistent through out the monitoring season.

Figure 9. Surface water pH concentrations at Mayo Creek YSI stations, 2010.

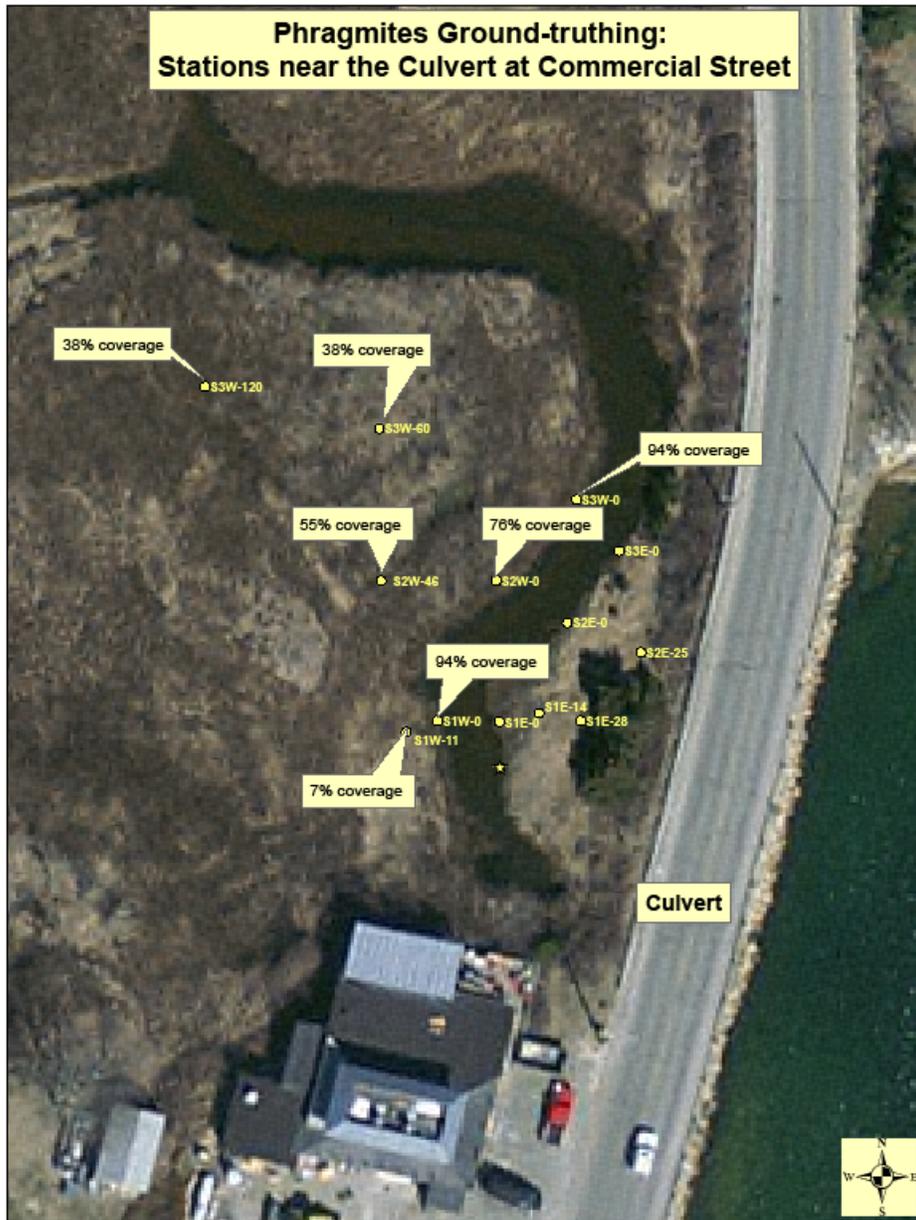
Map 2. Phragmites cover at stations on the study side near the culvert.

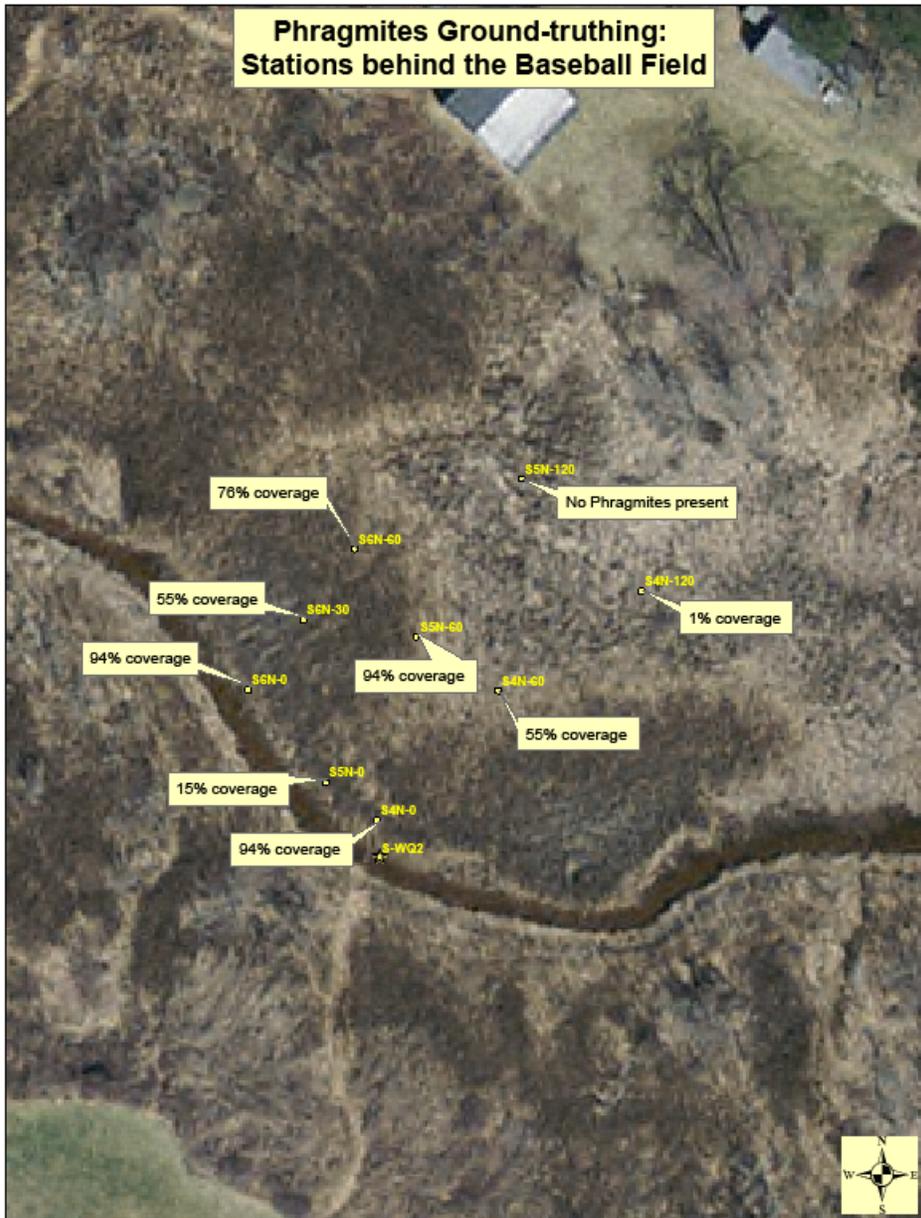
Map 3. Phragmites cover at stations on the study side behind the baseball field.

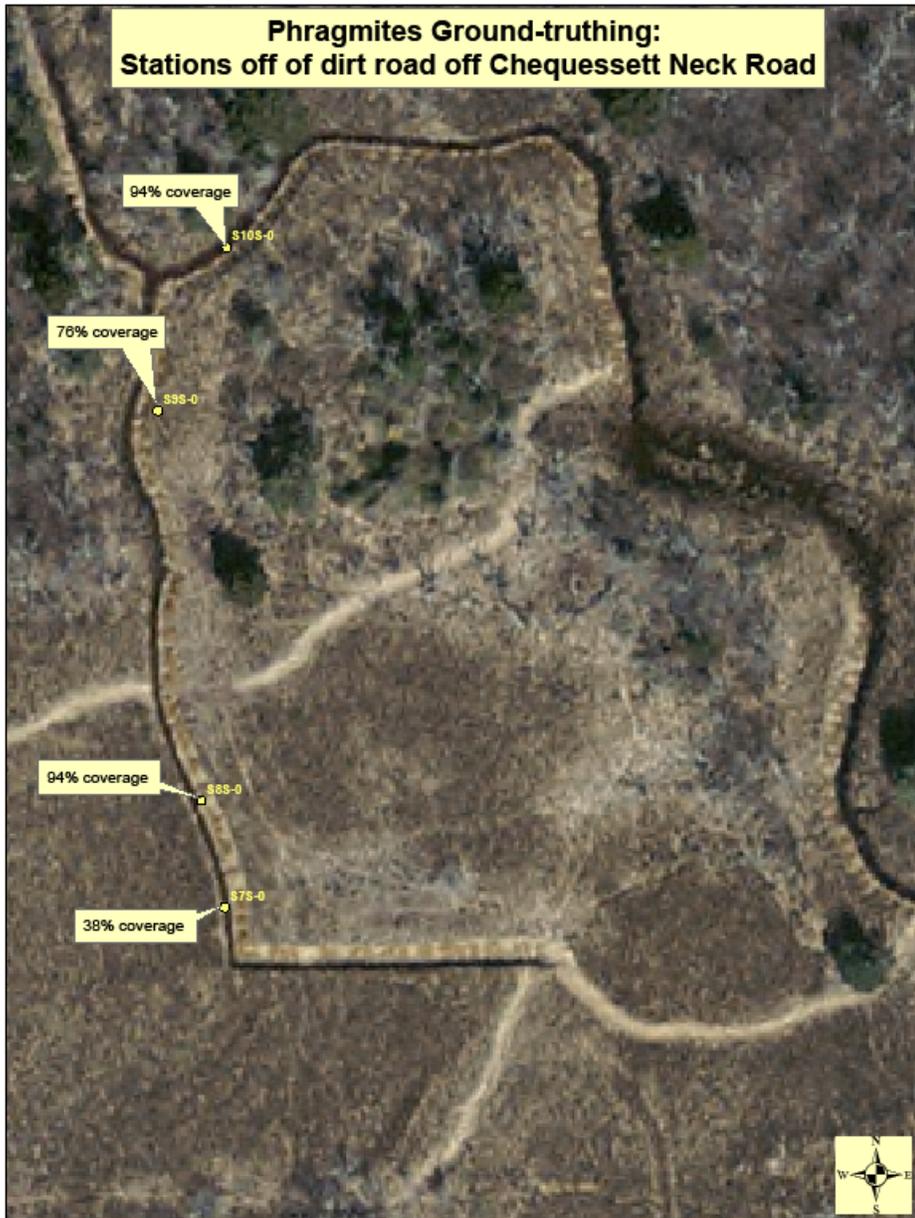
Map 4. Phragmites cover at stations on the study side off of the dirt road.

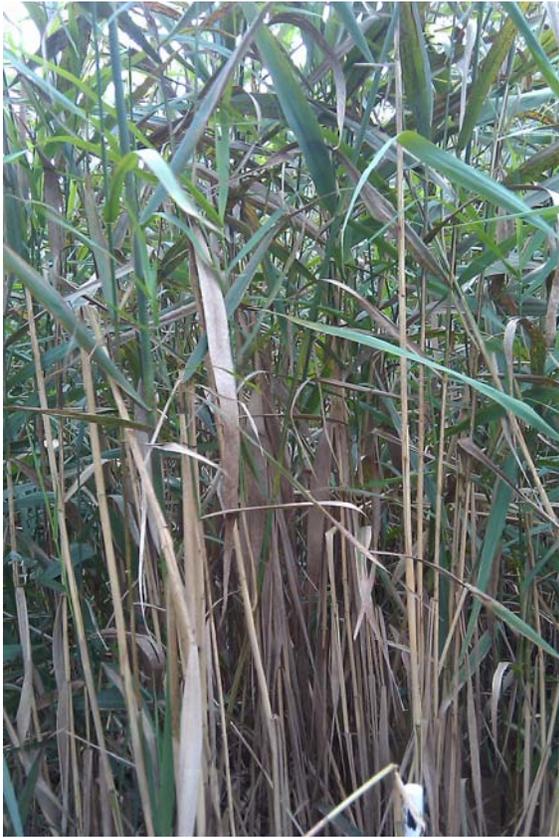
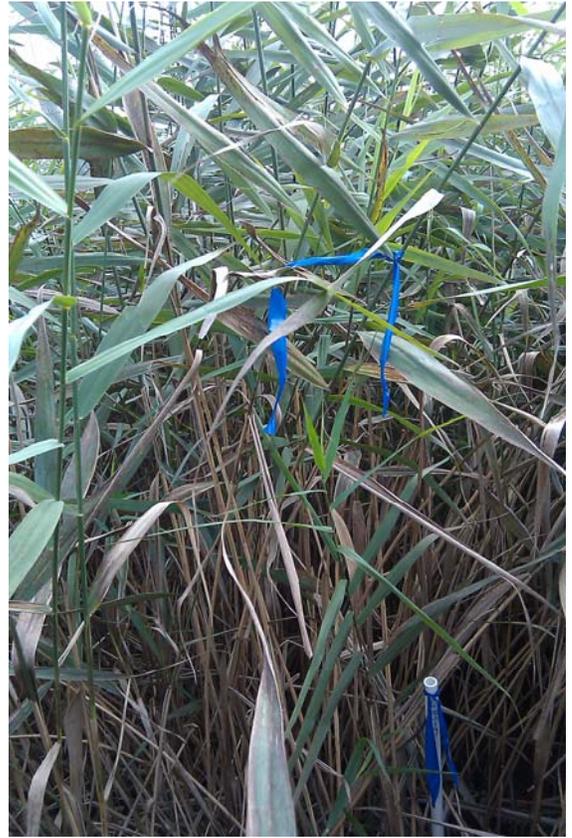
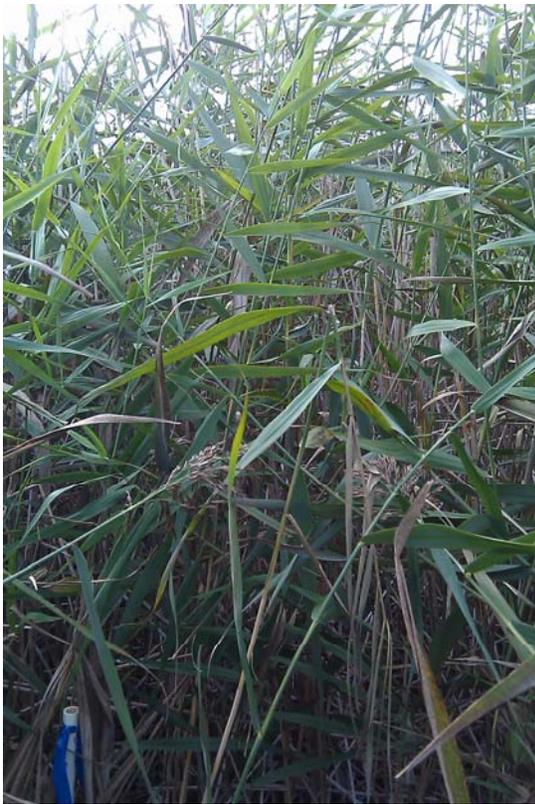
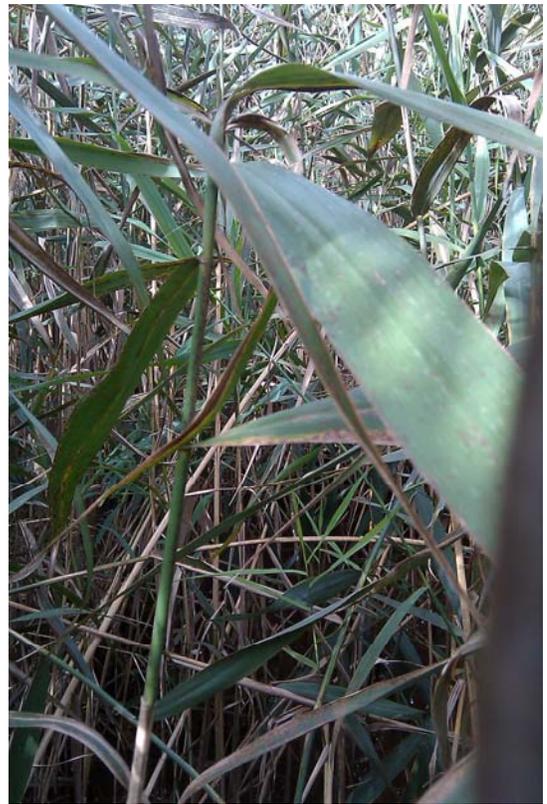
Photographs were also taken at the sites off the dirt road access running into Chequessett Neck Road. These photographs show the stations which consist solely of Phragmites. These photographs also show the standing water left behind on the marsh surface after Hurricane Earl swept through New England late in August 2010.
