# MAYO CREEK RESTORATION

*A NARROW PATH*

Mayo Creek Restoration Committee

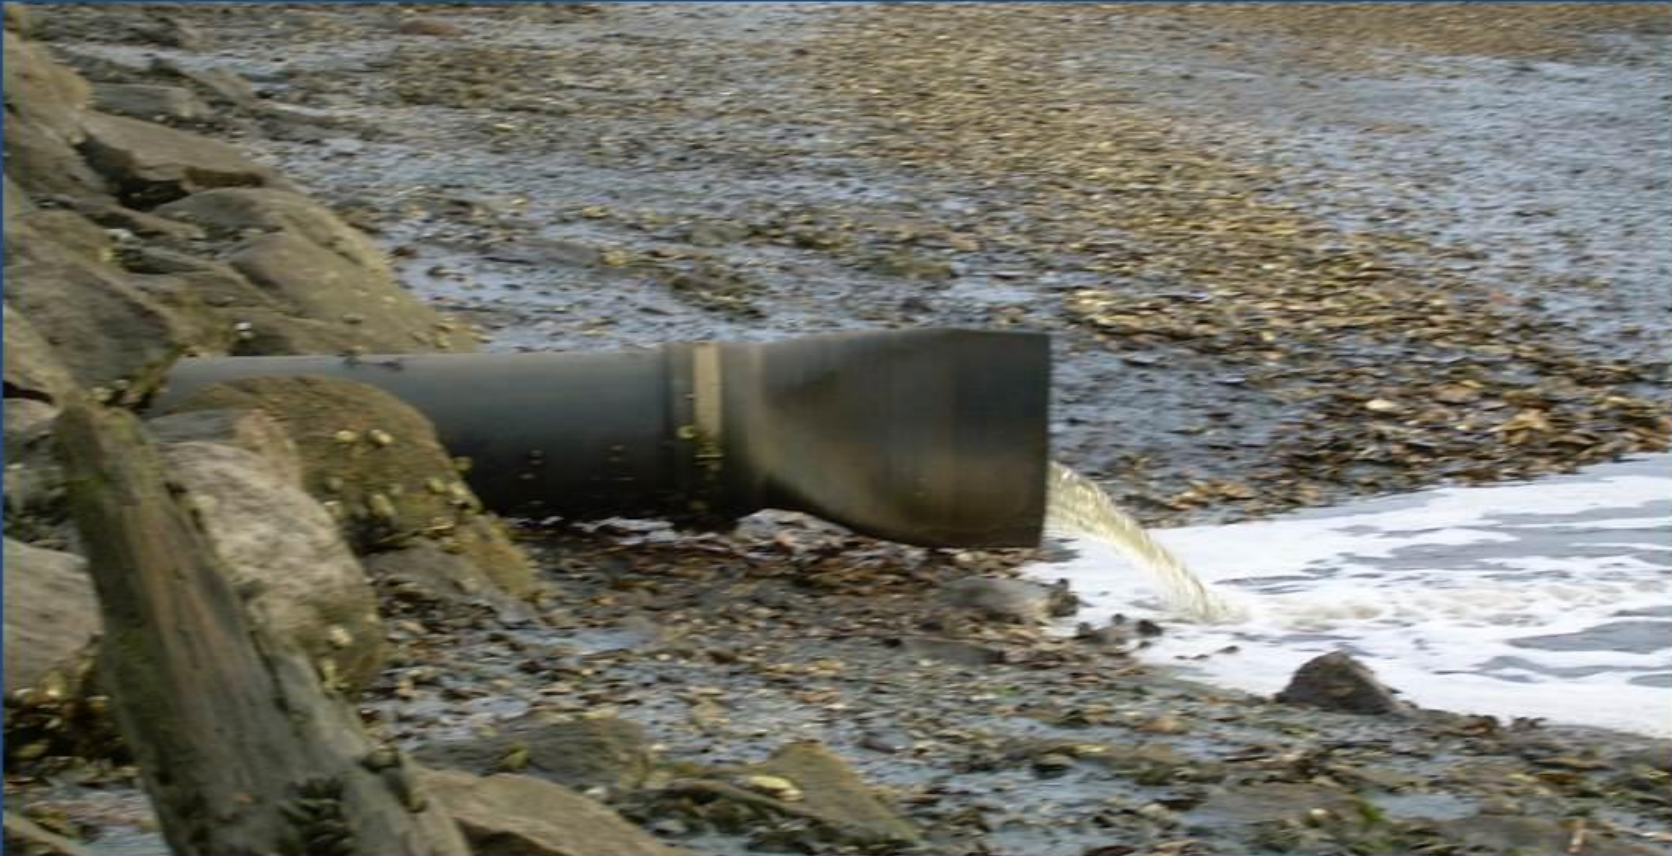
# Mayo Creek Today ... It Won't Work

# Creek Today

HARBOR	CREEK AS IS	GOAL
Mean High Tide	5.0	-0.8	<1.3
Mean Tide	0.0	-1.7	-1.7
Mean Low Tide	-5.0	-2.6	-4.7
Tidal Range	10	1.8

- Hydrodynamic modelling
- Current culvert cannot meet project goals
  - Can't balance marsh high tide with needed drainage
    - Opening too narrow
- Poor storm/rain drainage

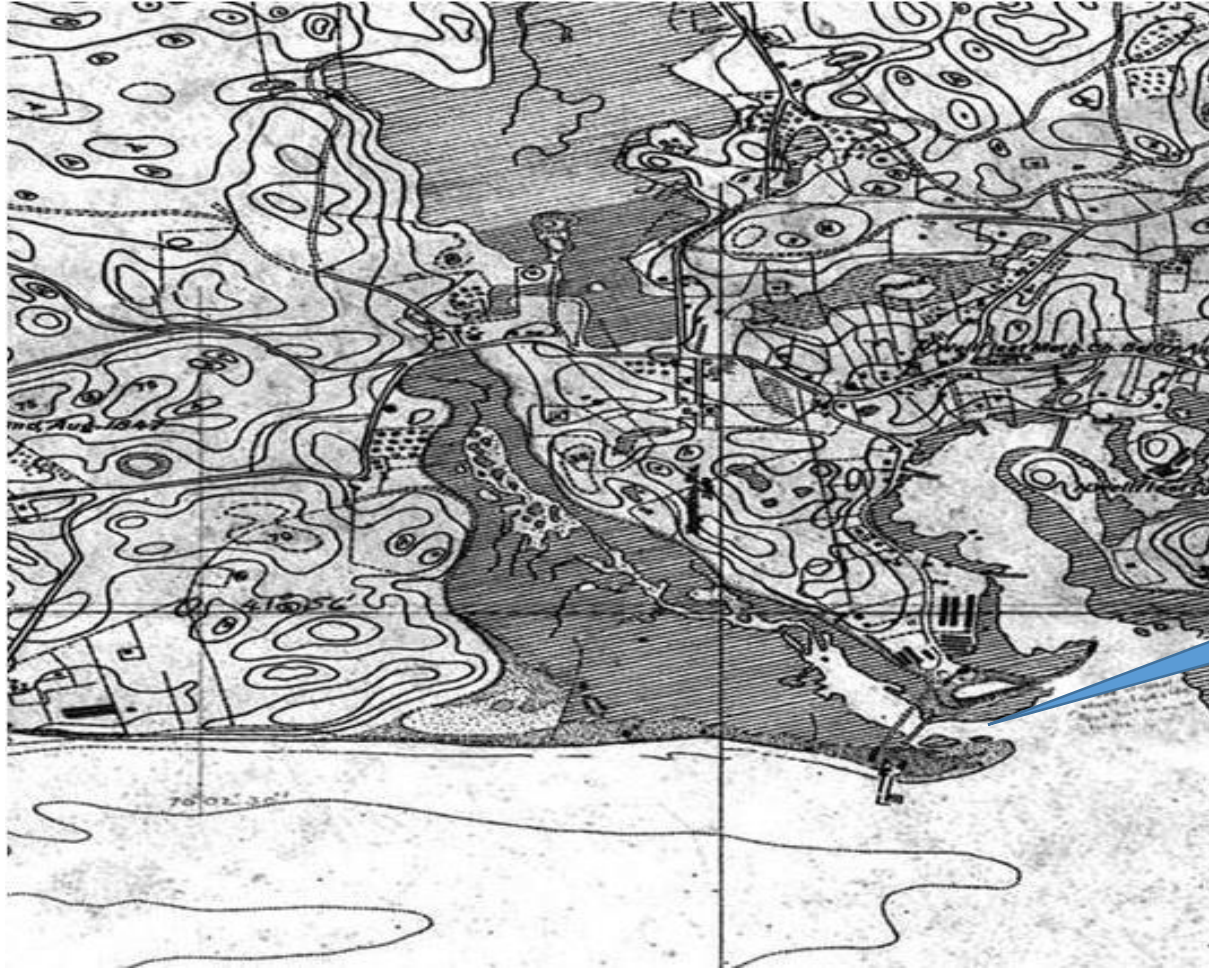
Mayo Creek 1848

INLET

# Real salt marshes ...

- Do not have a waterfall at the outlet
- Broad and gentle flood plain,  
at or near harbor mean low tide

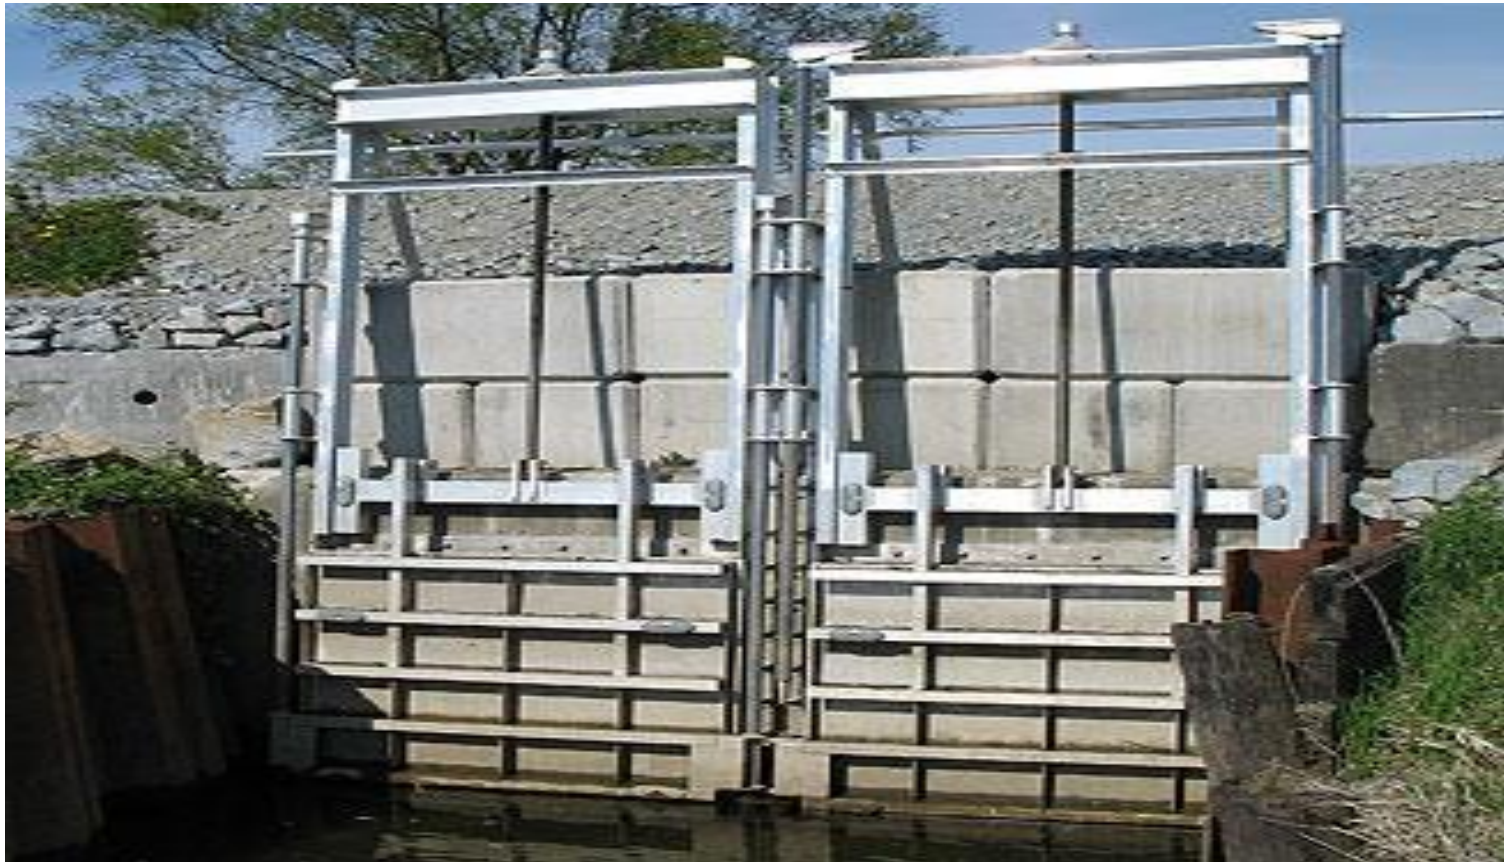
# New Culvert Gate

- Based on new modelling results (WHG/MassBays support)
- Invert - up & down stream - lowered to -5 feet
- 6-ft wide x 7-ft high box culvert
  - Culvert height for safety
- Stream channel dredged to match
  - Side channels in marsh to increase drainage, intricate channels
    - Including storm drainage
  - Compensate for loss of drainage network & narrow entrance
  - Help fish get to mosquito larvae
- Tidal gate for control: *adaptive management*

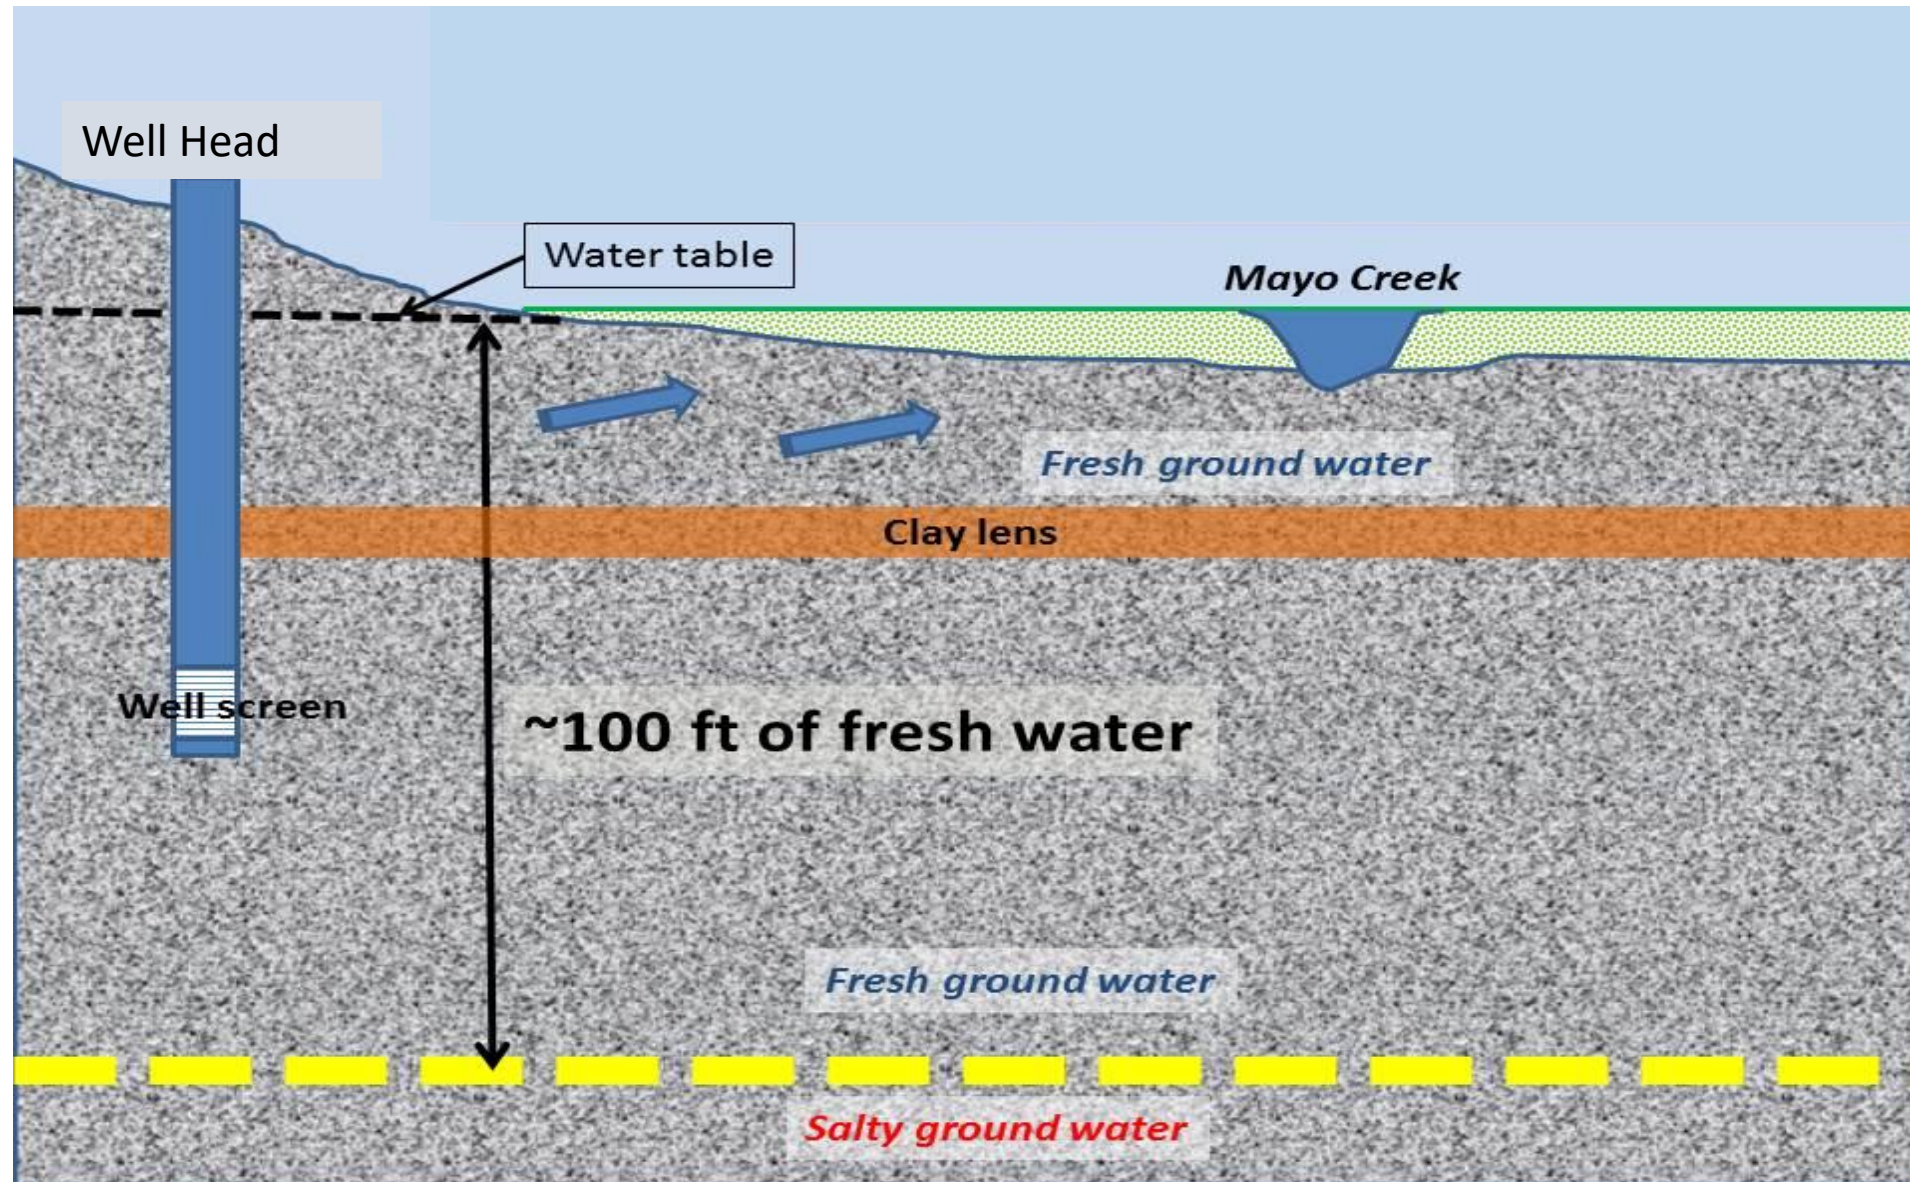
# Drinking Water Wells

- Drinking Water Wells
  - Well screens located typically about 50 feet deep in fresh water lens
  - Lens supplied by flow from adjacent uplands
  - Mayo Creek: Thick clay layer under the old marsh bed
  - All well heads are above the maximum 1.3 high tide limit
- Many abutters – but not all - on Town water
- More analysis to follow ...
