# MAYO CREEK SALT MARSH RESTORATION CULVERT DESIGN ALTERNATIVES

# **Mayo Creek Salt Marsh Restoration Culvert Design Alternatives**

December 2016

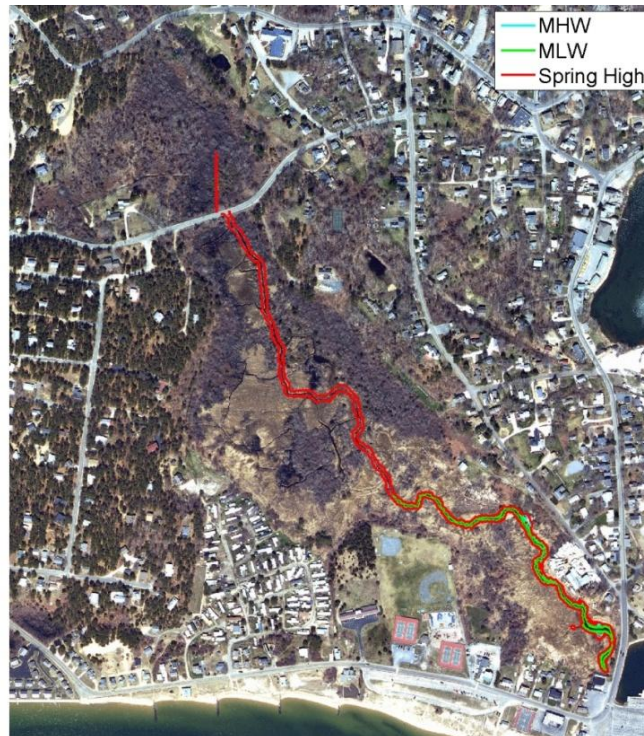
**Figure 4. Mayo Creek Basin with contours of MHW, MLW, and Spring High tide under existing conditions (does not consider rainfall). From Woods Hole Group, 2011.**

The ultimate goal of the restoration of the Mayo Creek system is to improve the health of the marsh by increasing the tide range and, therefore, the intertidal area within the marsh. As discussed in 2011 Woods Hole Group study, the current intertidal zone is limited to the banks of the perennial stream (Figure 4), and the tidal range is less than 2 feet (compared to nearly 10 feet in Wellfleet Harbor).

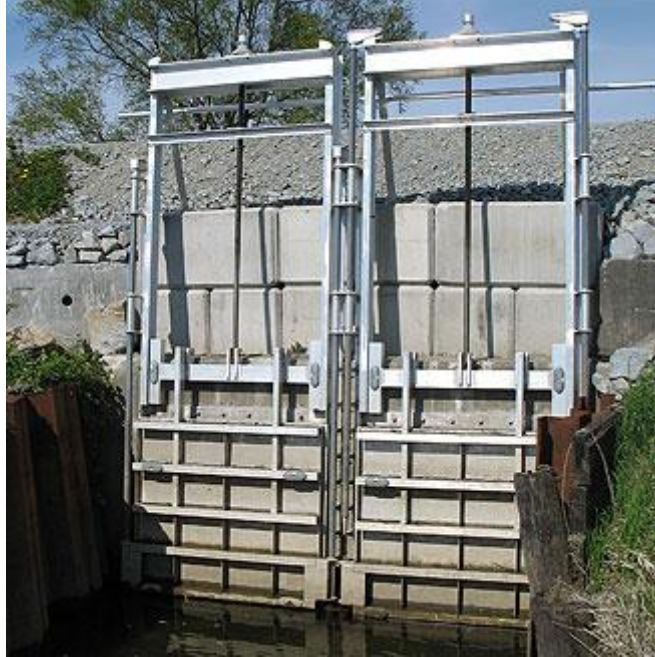
**Figure 15** Golden Harvest GH-50 sluice-flap combination gate.

While all tidal control measures evaluated above include the use of a self-regulated gate that would automatically close when a specific water level was reached in Wellfleet Harbor, the use of a combination gate (Figure 15) was also considered. This type of gate slides opens to various opening elevations such that there is a limited opening on a incoming tide, but is able to flap completely open during an outgoing tide to allow increased drainage. This allows for a non-linear exchange of water into and out of the system. To model this scenario, the height of the sliding gate was adjusted to maintain the MTL while allowing the full height of the culvert for the drainage of the system. The sliding gate for the non-excavated 4'x5' foot proposed culvert would require a small 0.15-foot gap at the bottom of the culvert to maintain MTL of -1.7 ft (Table 6). For the excavated case with a 6'x7' foot box culvert, the sliding gate would require a vertical gap of 0.75 feet. The drawback of using a combination gate for tidal control is that during storm events, the gate would allow additional water in to the system as compared to a self-regulating tide gate. The combination gate would need to be manually closed during an impending storm surge scenario in order to ensure that high water in the Mayo Creek system does not exceed the maximum required water surface elevation. If the combination gate was not manually closed, higher storm surge based water surface elevations could be expected in Mayo Creek.
